Design
Build
Products
Nursery

Afon Gwydol Embankment

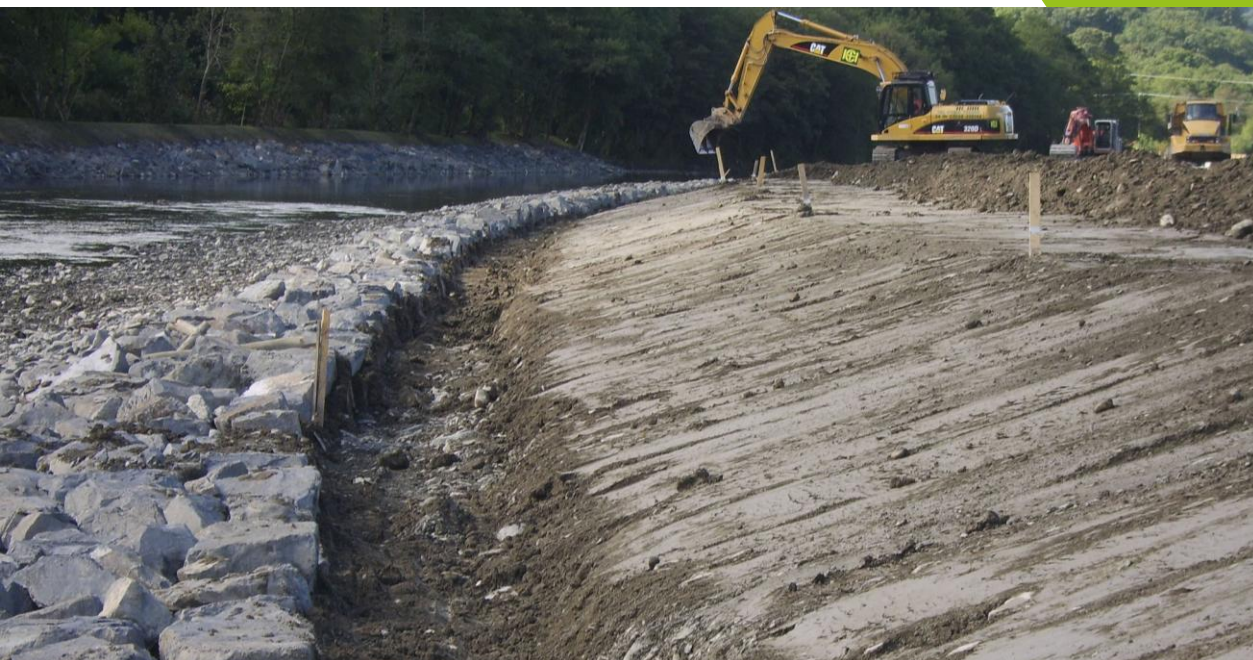
Works were required to repair an eroding railway embankment adjacent to the river. This resulted in the embankment encroaching into the river, causing erosion problems on the opposite bank belonging to a local farmer.

Difficult site access created problems for using large blockstone. Salix replaced part of the blockstone armouring with VMax P550.

The P550 is the highest performing composite Turf Reinforcement Mat (TRM) in the UK. Compared to blockstone armouring it is also a more environmentally sustainable, cost effective solution that was easier to install. It also blended in better with the environment.

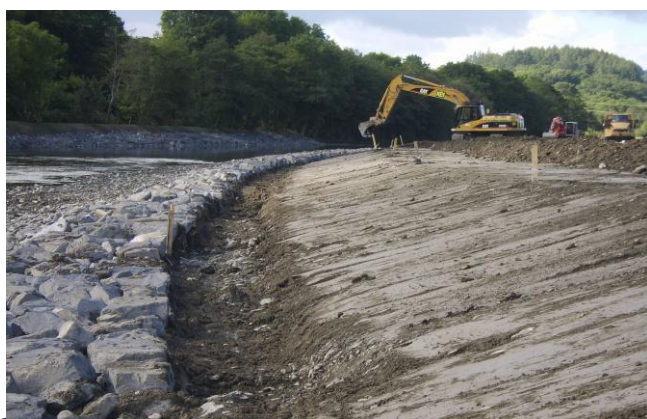
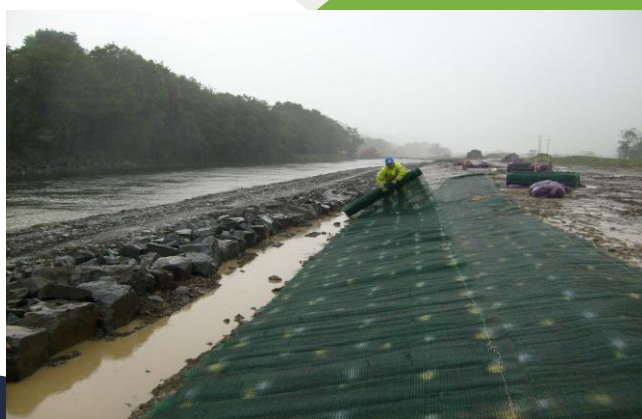
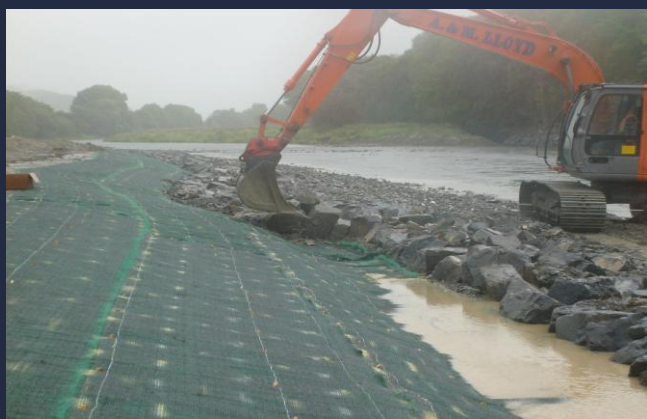
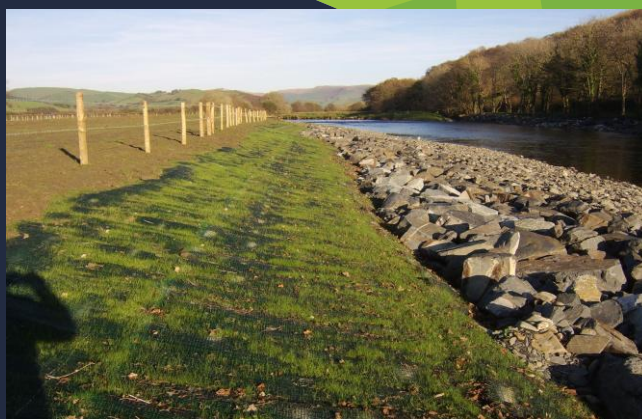
Anchor trenches were dug at the toe and the top of the slope to ensure the P550 was not washed away during the winter floods.

Under Salix supervision, Carillion Rail dug the trenches and formed the slope ready for Salix site operatives to seed the area with a specialist river mix and manually install the P550. The area was also over planted with some wetland plants.

The works were carried out at the end of October, which meant that the P550 remained only partially vegetated throughout the winter months of frequent flooding. By the end of the following Spring, there was no soil erosion and a good rate of vegetation establishment.
