Design
Build
Products
Nursery

Kingsbury Tamworth Rail Line

Salix applied HydraCX in September 2009 to slopes consisting of 6l/J fill material with no imported topsoil covering the surface. The project was monitored each year to see how the vegetation established.

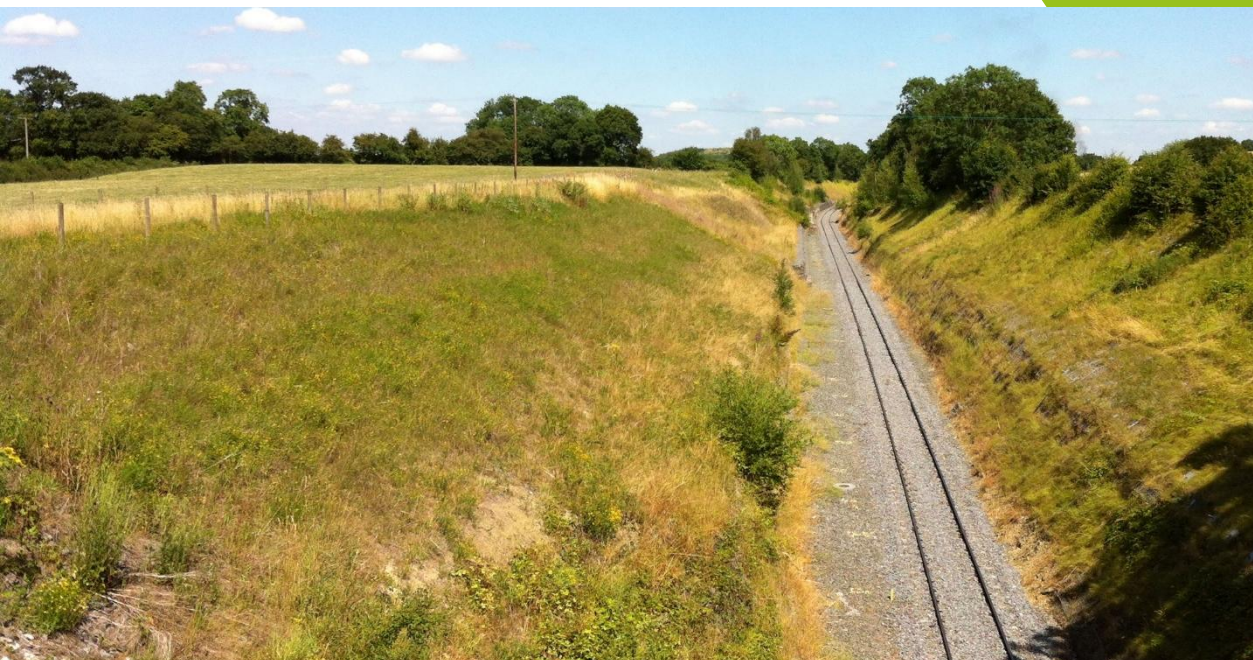
Due to the high stone content on the surface, Salix requested the main contractor to rake the top surface area to expose the fines below. We then sprayed this with HydraCX, our hydraulically applied erosion control blanket. Some areas were nailed and rock netted.

One hour after the works finished at Tamworth, we experienced a massive rainfall event. The HydraCX is designed to withstand intense, heavy rainfall without washing off the surface. Therefore, we did not need an erosion control mat or net to prevent erosion of the slope plus the HydraCX spray on erosion control blanket provides far quicker germination and prolonged vegetation aid than standard hydroseeding.

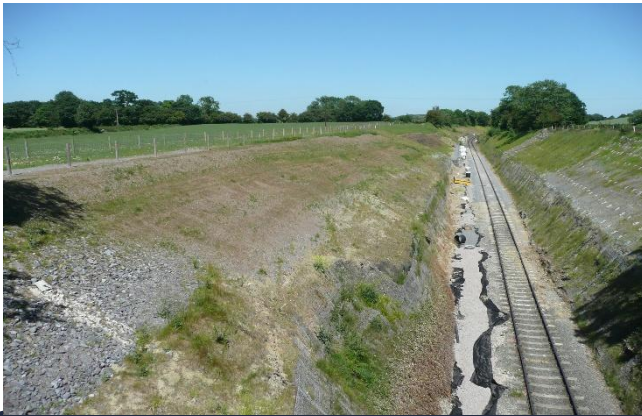
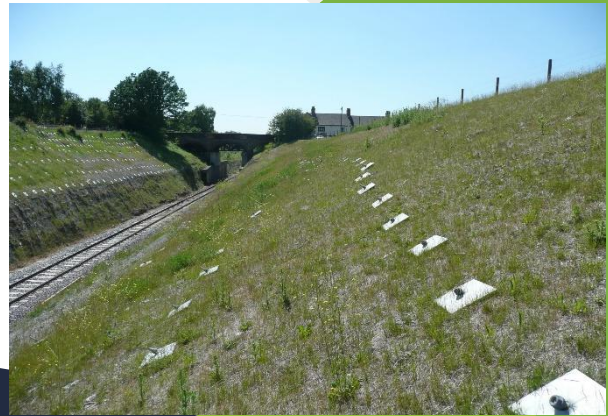
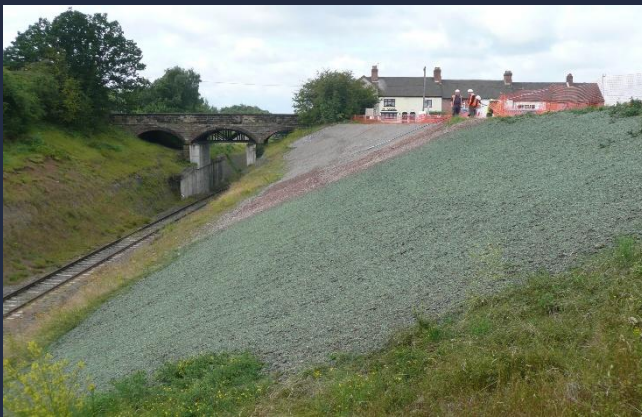
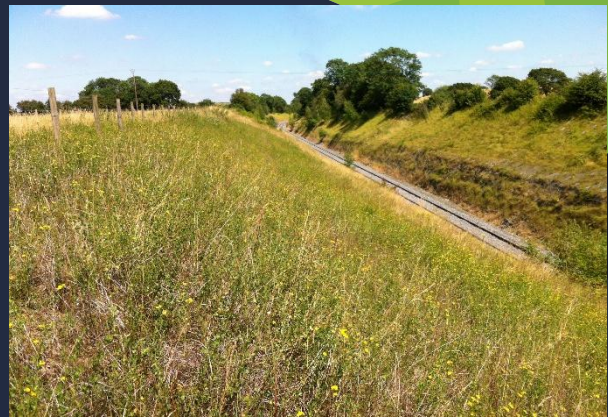
The photos show how the site has developed over the years. In November 2009, two months after Salix applied HydraCX, the area was well vegetated. It then gets battered by the sun and dry conditions during a very dry Spring as you can see from photos taken in June 2010.

Some of the initial species we used in the reclamation seed mix added to the HydraCX have died back adding some nutrient and water retention to the surface allowing colonisation by wind blown species that can tolerate infertile conditions. Our initial seed mix has acted like a “nurse crop” allowing colonisation to take place.

The important factor in successful vegetation establishment on very poor ground, is to get something to take initially, i.e. a nurse crop and then let nature take over and sort itself out over time.
