Protecting a Pipeline in Carmarthen

Salix were brought in as specialist contractors to help deal with an exposed pipeline in a river near Johnstown, Carmarthen.

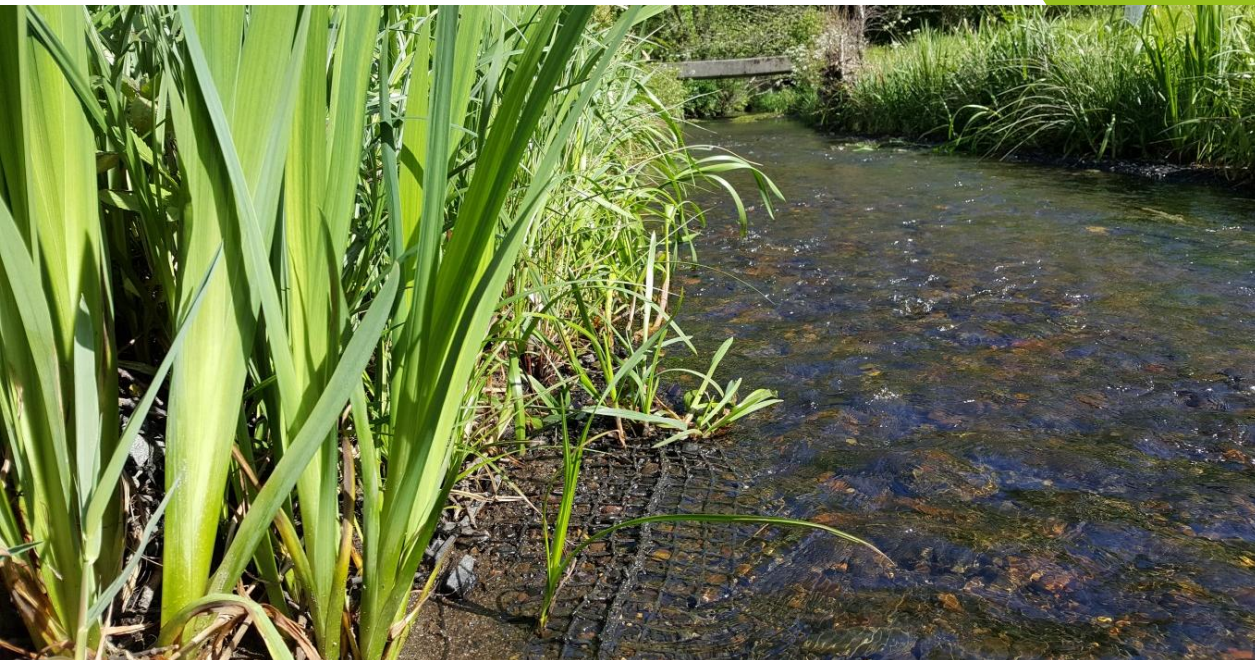
Two trees growing on the riverbank had dramatically narrowed the river, impacted the flow, and created a large scour pool directly over the pipeline.

Salix went on site and did a full geomorphological and ecological survey of the site and recommended the site was dewatered whilst the pipeline was moved to a more stable channel crossing point.

Salix's Rock Rolls, erosion control coir matting and pre-planted Coir Rolls were used to ensure the riverbanks were protected from erosion.
