Ramsden Bellhouse

A series of potentially dangerous deep-seated failures on a railway embankment required treatment to prevent further slips.

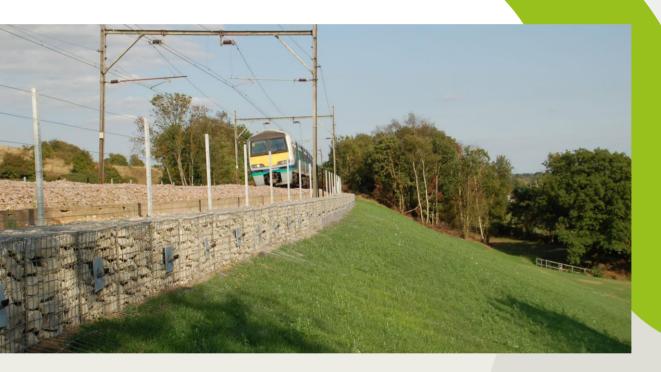
The geotechnical issues of ground stability were resolved using soil nailing. The surface erosion was solved by using VMax C350. C350 is a composite Turf Reinforcement Mat (TRM) and was installed over prepared seeded topsoil.

The whole surface was then covered with rock netting.
