River Towy Bank Erosion

Salix was awarded the contract by Carmarthenshire County Council to repair ninety metres of bank erosion that had caused the footpath to collapse into the River Towy in the centre of Carmarthen.

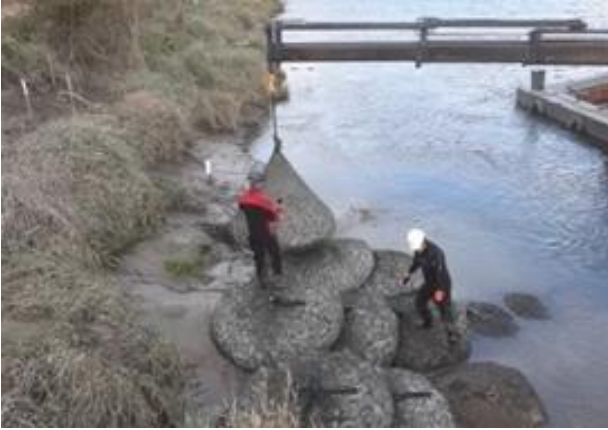
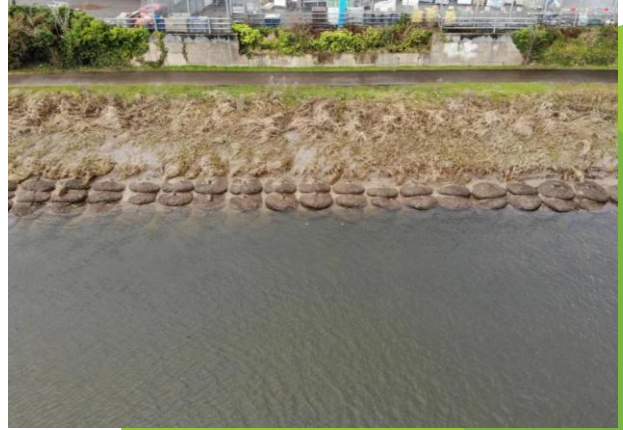
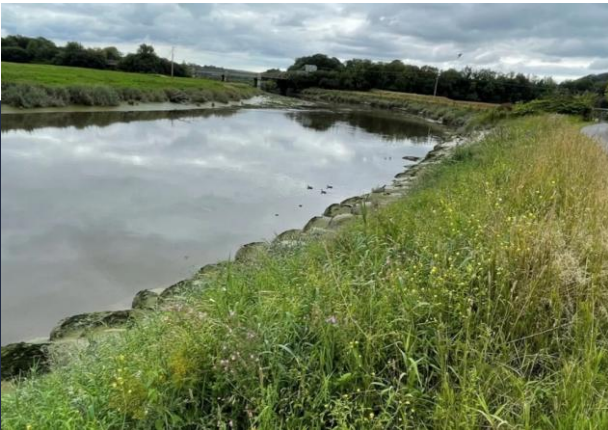
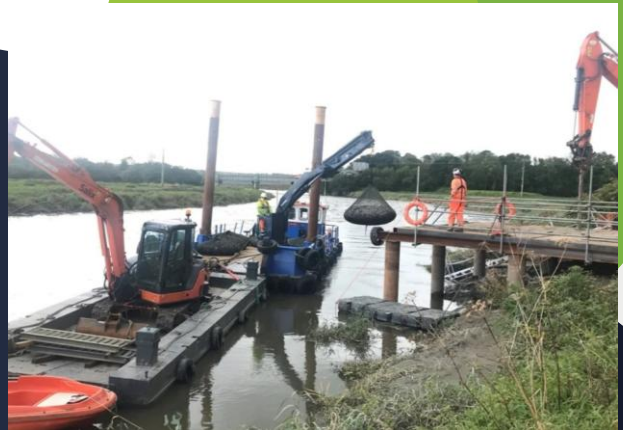
AquaRockBags were installed at the eroded toe of the falling riverbank. Brushwood was then applied to the surface of the newly formed slope.

The brushwood trapped fine sediment and vegetated naturally to quickly stabilize the surface of the new slope.
