Beacon Park

Salix were employed by main contractor Casey to undertake the restoration work to Beacon Pool for Lichfield Council on this Heritage lottery funded project.

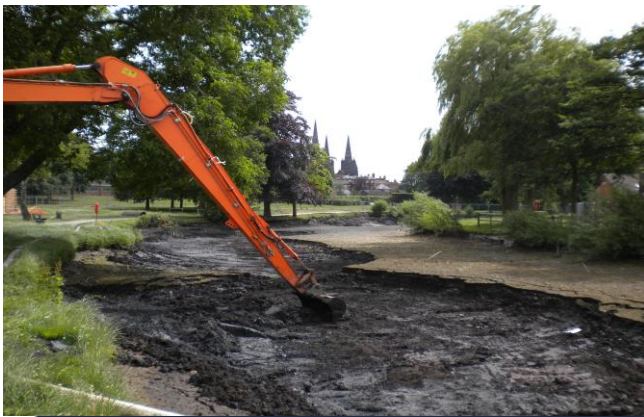
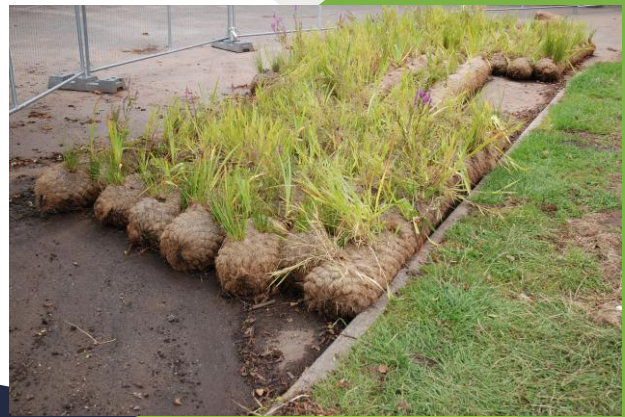
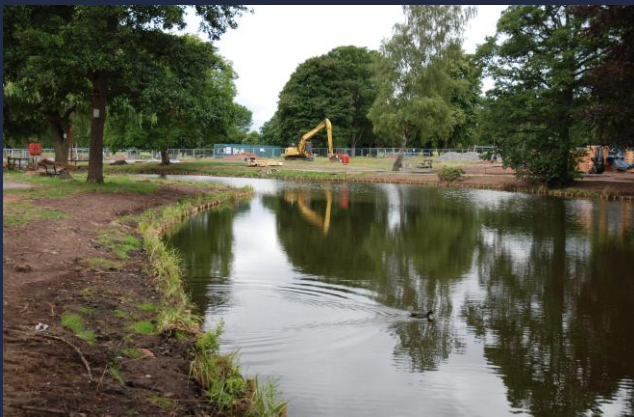
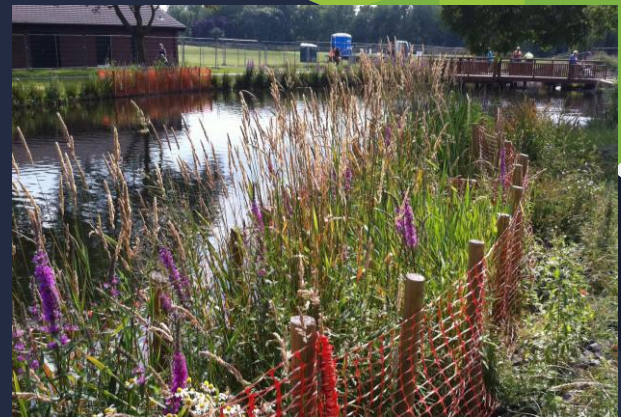
The lake was heavily silted with sediment deposited from the brook and with many years of decaying leaf litter. The lake was created many years ago by filling in over peat bog which left the lake with soft and rapidly eroding banks of made ground.

Silt was then removed using long reach excavators on timber tracking mats as access to the bed was not possible in water-logged peat. The silts were placed in a drying area on site for use in landscaping.

The erosion was controlled by placing pre-established Coir Rolls over fascine bundles. The rolls were then backfilled with silt from the lake to fill voids created by undercutting wave lap action.

To prevent any migration of silt in this crayfish sensitive water course, Salix chose to over pump and dewater the lake.

The soft bank protection was broken with areas of timber capped sheet piling to offer lake side access to this important amenity lake.

The lake was completed by adding a piled hardwood timber walkway to cross the head of the lake with a viewing platform overlooking the pool towards the spires of Lichfield.
