Canal Bank Remediation

To provide remediation of approximately 400 metres of canal bank.

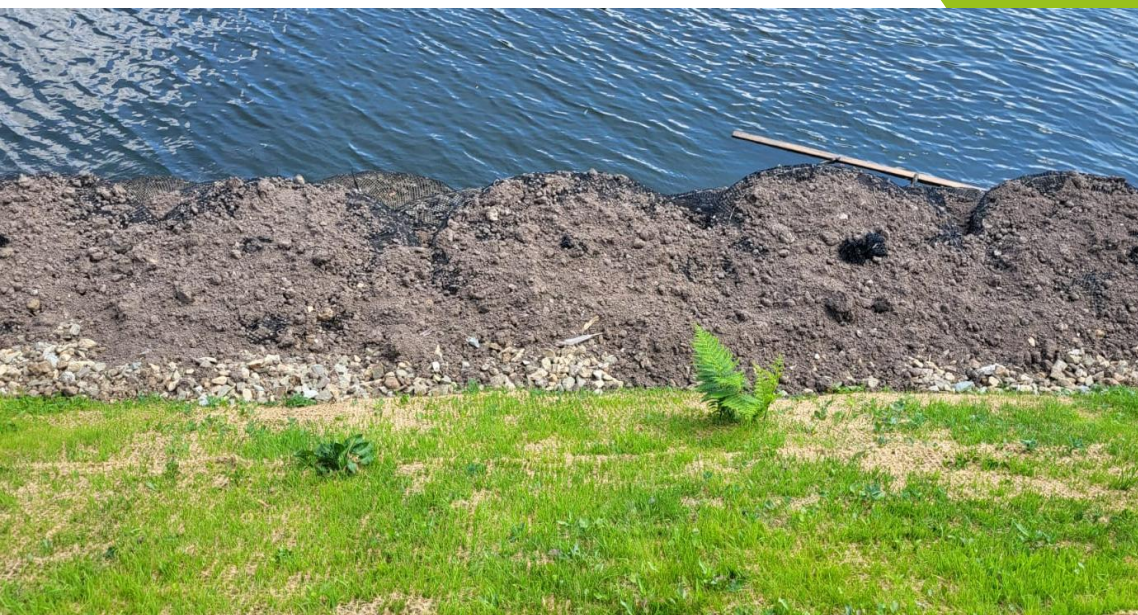
Salix was contacted by Marshall Construction to provide remediation of approximately 400 metres of canal bank on the Manchester Ship Canal at Irlam Wharf. The 400 metres was divided into six zones of varying levels of erosion requiring different solutions. The erosion issue appeared to have been caused by significant 'wave action' over a lengthy period of time, in what is a busy stretch of canal.

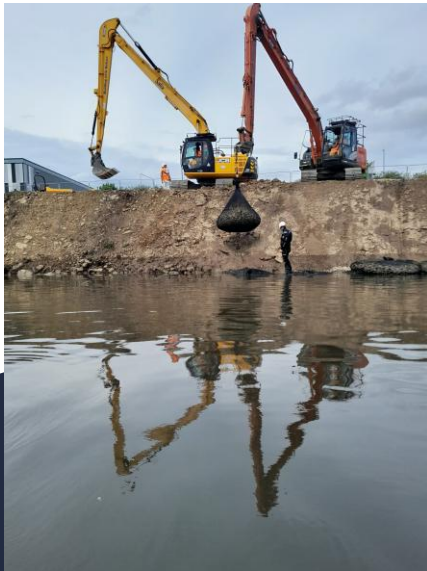
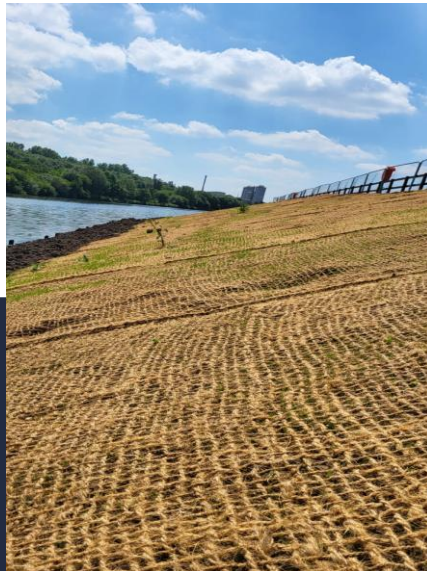
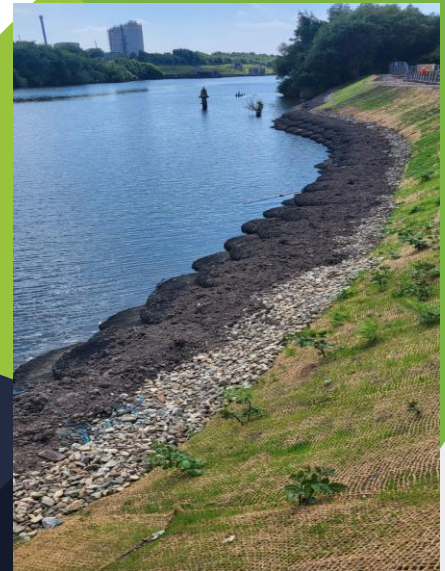
Working from the top of the bank, using a JS220 15 m long reach excavator, we cleared vegetation from the full length of the bank, with off-site removal, in preparation for the installation work. We then set the line from the toe to the existing boundary.

In four of the zones, we used 164 2t and 80 1t aqua rock bags to fill the banks and used a clean granular fill behind the rock bags to bring the stone above the water level. This continued until the desired height was reached before we placed imported soil on top.
