# River Washford Roadwater Erosion Protection

The River Washford runs through the village of Roadwater near Minehead, Somerset. The catchment creates a flashy river which floods parts of the village in large flood events. The increasing frequency of flood events required the existing system to be replaced and improved.

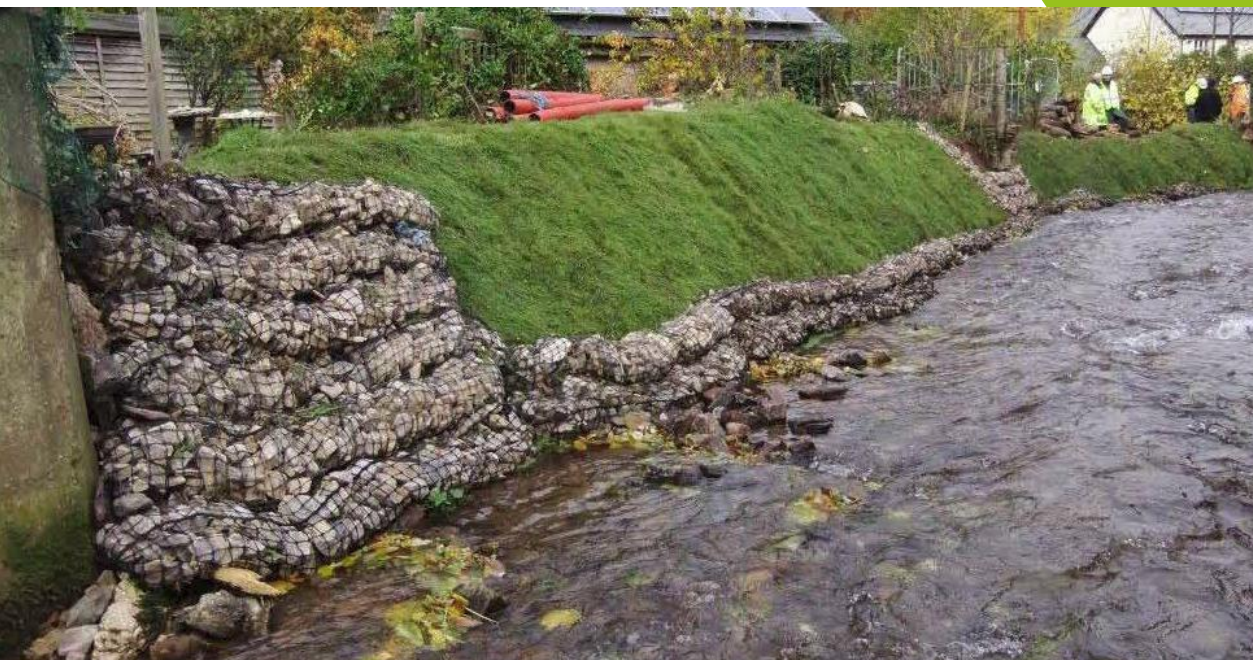
A forty metre section of the river which had timber piled revetment running between properties required urgent attention. These piles were at the end of their working life and new erosion protection was required. The site was constrained on both sides and as such a conventional system was not feasible.

The old wood piling was removed and the bank behind was graded to about 45°, as shallow an angle as achievable. The scrub and soft vegetation was removed, leaving the small bankside trees as they were integral to the bank stability.

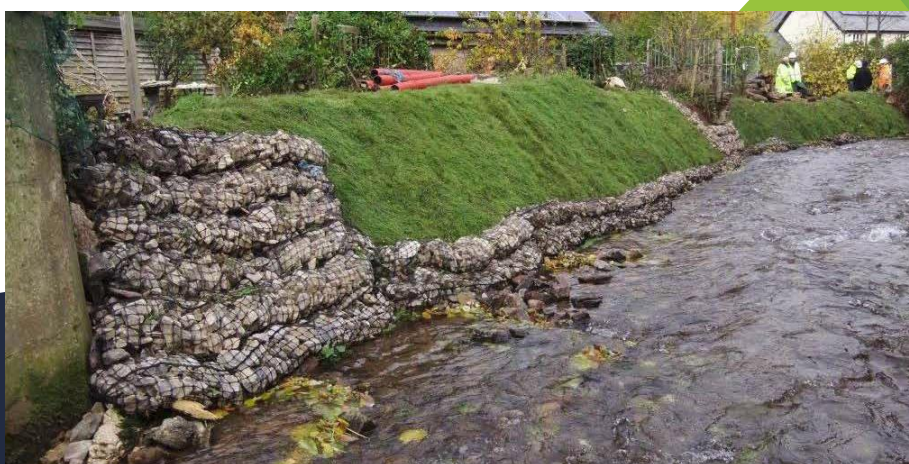
The new bank protection provided a robust toe and a reinforced turf slope. This combination has the required shear stress resistance to the flow during peak flood events. Rock Rolls are 300mm diameter high strength nets ready filled with stone and were used instead of riprap or gabions.

They were placed to provide “engineering” resistance to flow and also to create natural features with habitat value. They are sewn together where they touch to create one mass, either in line or where stacked up the slope.

The pebble bedload was thought to be mobile, so site won brushwood was placed around them to slow the water and reduce potential impact. As the slope was so steep and this was a live repair, Salix installed “Shear Stress Turf”.

This is a turf reinforcement mat (TRM) grown off-site and therefore has immediate resistance to 6m/s flow. This reinforced turf instantly provided the required performance in this confined site.
