Silverthorne Sheet Piling

Salix was commissioned to undertake the design and build for a sheet piled wall with a reinforced concrete capping beam. This was to replace a failed section of timber wall at the Silverthorne Lane, Bristol remediation Project.

Case Study

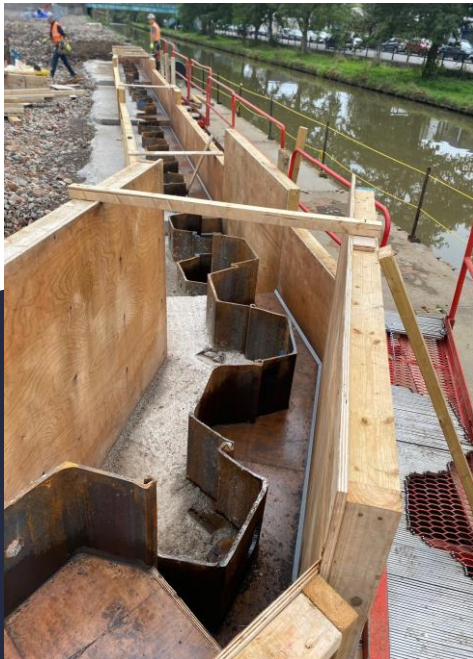
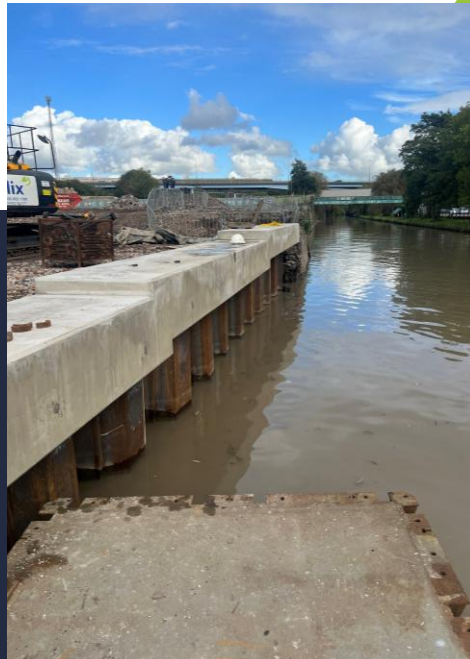
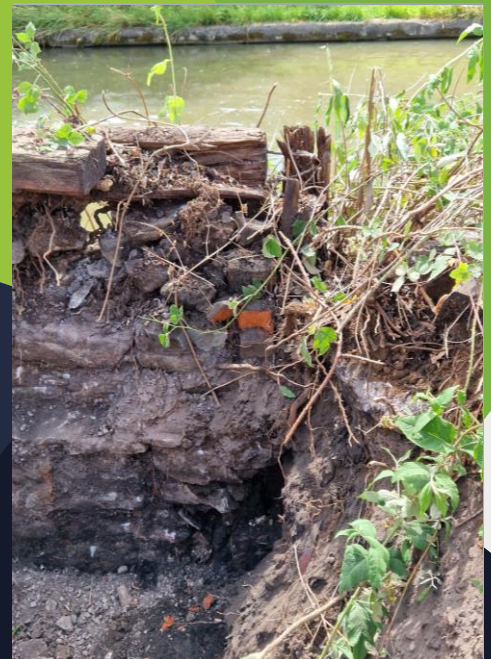
The main contractor installed a reduced-level piling mat to create our working platform. With our JS220 long reach excavator we carefully removed the existing timber posts which had been driven into the bed along with the transverse timbers. This allowed us a clear line for the proposed sheet pile works.

After the timber sections were removed, we agreed the tie-in points with the client. Due to the poor condition of the existing wall structure this proved particularly challenging. We dug Trial holes to establish the depth of the existing wall foundations and identify if there was a batter on the rear of the wall as this affected the removal of the existing structures and the placement of the sheet piles.

To temporarily support the existing wall, we installed timber frames and temporary Z piles. For the water side over the existing concrete inlet, where temporary piles could not be used, we installed Salix 2t Aqua Rock Bags®.

Under the supervision of a safety boat, we installed our interlocking Nato pontoons to provide a safe working platform for the water side of the works. Our skilled operatives also installed the safety line and signage in line with our rescue plan.

To protect the watercourse, we installed a silt curtain and oil booms around the rear of the Nato pontoons ensuring that we protected the working environment and were compliant with all relevant EA standards and our approvals.

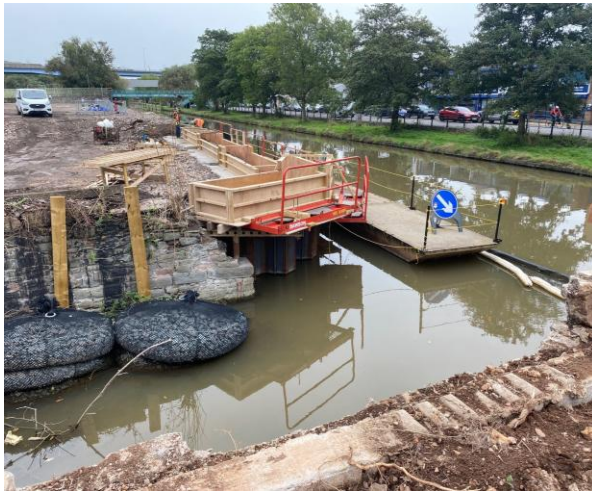
Once the alignment was set out, we mobilised a Movax SG-75 mounted on a 35t excavator with DX25 BSP piling hammer to install the 13m Larsen sheet piles. We faced additional challenges with the tie-ins, which led to us installing sacrificial 'Z' piles with an omega clutch at each tie-in point. This brought the sheet piled wall in behind the existing structure.

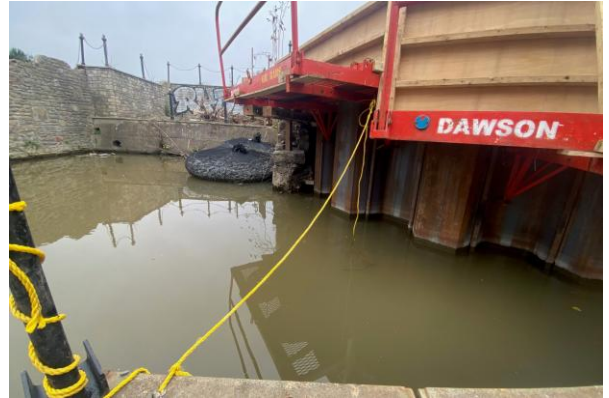
During the sheet pile installation, not anticipated based on the client-supplied ground investigation, some piles were driven to failure. We mobilised an impact hammer to back drive piles to depth, exercising extreme caution to avoid pile deformation. On completion of the back driving exercise, a small number of piles reached failure at depths from finish levels ranging from 350mm to 1100mm, which required an instruction from our client, to mobilise an oxy acetylene cutting team. We recorded details for each of the piles, noting sheet pile lengths, toe depths and noting depths for refusal.

We backfilled the sheet piles with a self-compacting gravel up to the underside of the formation level for the capping beam, leaving a gap for shuttering installation. Blinding concrete was installed landside to provide us with our level for the concrete capping beam shuttering. To ensure that the gap between the new and existing structures was fully sealed, we used mass pour concrete.

On the waterside, we utilised the Dawsons sheet pile capping beam system to create our platform. This was set at various levels to account for the 4 No. of level changes in the finished level of the capping beam, which was to be utilised for surface water runoff.

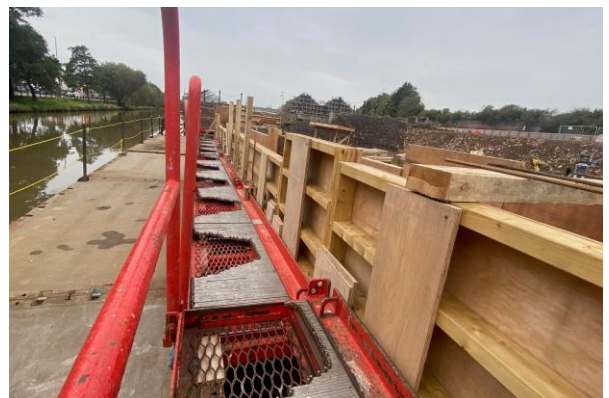
Following the fixing of the steel sections and tie-bars, we achieved client sign off. We undertook pre-concrete pour inspections, and a concrete pump was mobilised. The concrete was poured in one visit with vibrating poker ensuring that there was a consistent finish to the concrete and any air bubbles removed. Cube samples were taken on days seven and twenty-eight, with crushing was commissioned to check strength compliance.
