Design
Build
Products
Nursery

Soham Lode Re-visited

An important water vole site at Soham Lode required emergency re-lining of the perched section of the reach (approximately 600m). Following the emergency works, Salix were awarded a Design & Build contract on a competitive bid process to reinstate the marginal vegetation and green up the embankments.

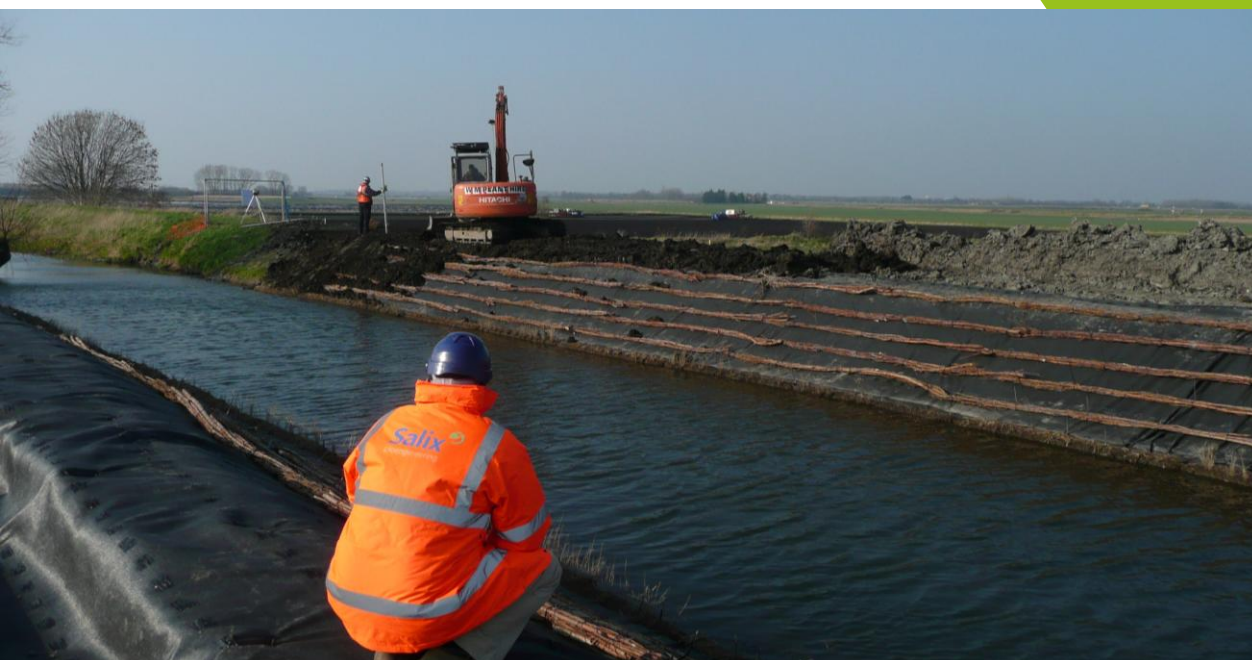
The liner prevented stakes being used and created a slippery surface for soil placement. Therefore, a woven loop geotextile was used over the liner in order for Coir Rolls and brushwood fascines to be tied onto the loops.

The brushwood fascines created a physical barrier preventing the soil fill placed on the banks slipping down the slope. A total of 1200m of pre-established Coir Rolls was placed along the toe of each side of the re-lined section to form dense marginal planting.

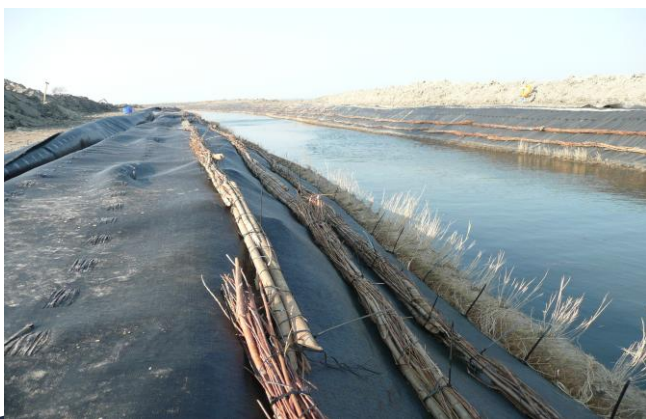
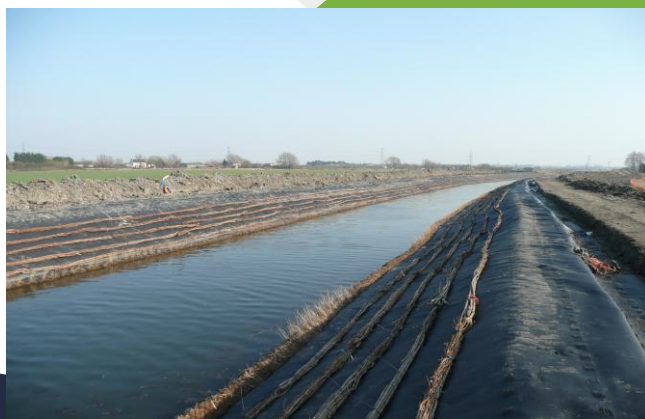
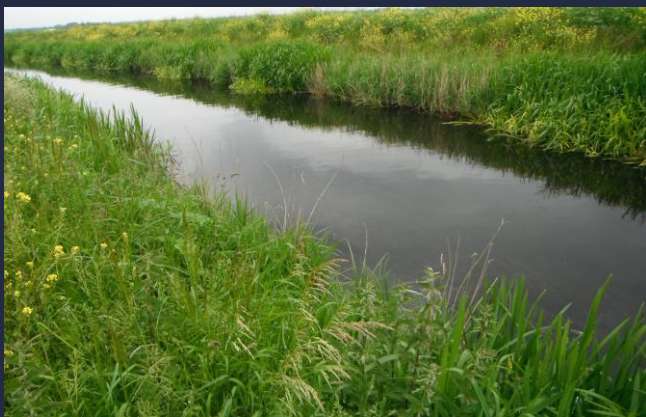
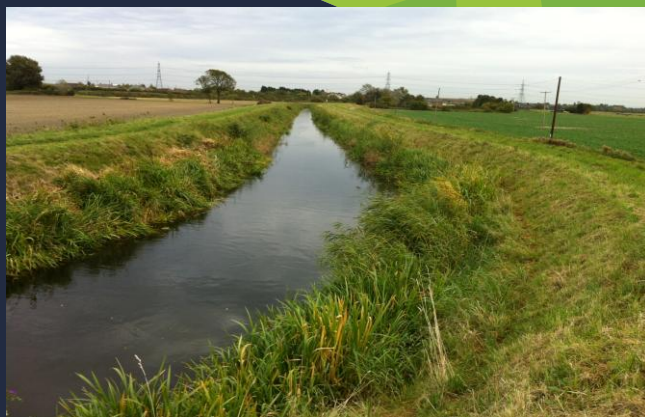
The marginal vegetation has flourished during the spring/summer months and has created a functional corridor for many species. Following a “spot-check” on the 11th August 2011, FRB can confirm that water voles have also returned to the re-lined section: both droppings, including a latrine, and feeding signs were recorded.

This is an excellent result as the Coir Rolls were only installed in March 2011 and are already providing suitable habitat for the water voles.
