# Lake Taf Bargoed

## Remediation Design & Works

Lake improvements to help fish habitats and use for water polo.

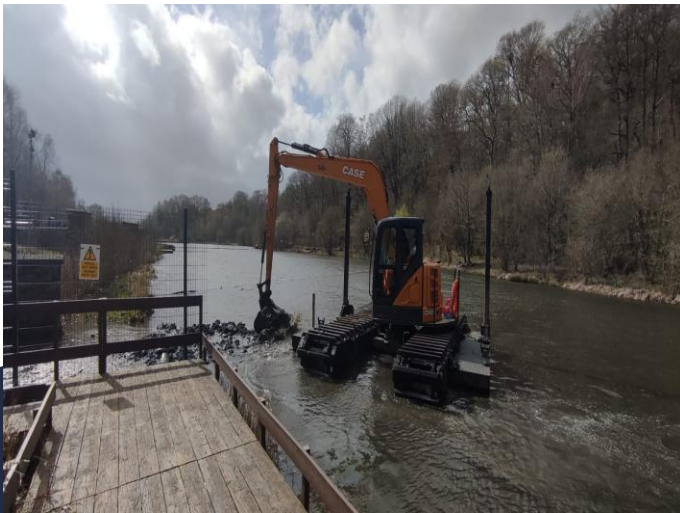
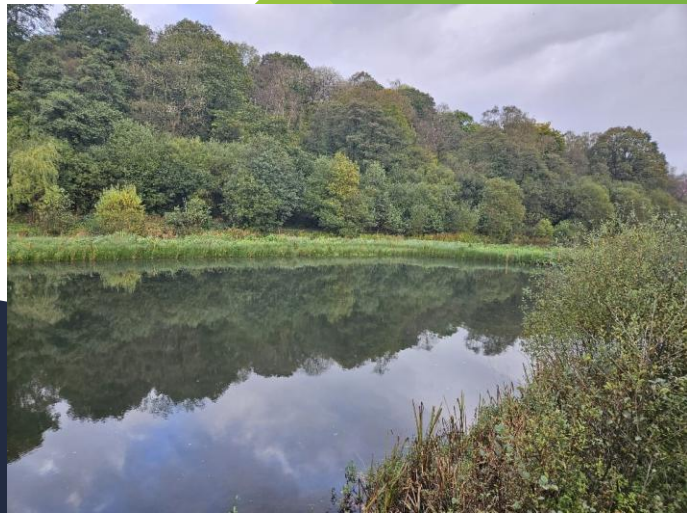
The scheme was to create a long linear island to divert the main flow to one side of the lake and over the weir while the lake would be deepened to 1.2m to allow the water polo to continue. Local deeper pools would also be formed to improve fish habitat and fishing.

Salix mobilised to site and began to construct the linear island from Nicospan. It soon became apparent that the bottom half of the lake had been backfilled with rock and rubble during the construction of the dams during the 1970s. This put the whole project at risk as the stakes supporting the Nicospan could not be installed. Salix met with the council, fishing club and kayak club to openly discuss their requirements and what could be achieved considering the ground conditions.

While compromises in what all parties had hoped to achieve, we were able to desilt one area of the lake to enable matches to be played for years ahead and the upper part of the island was constructed to improve biodiversity to the lake and allow deeper pools to be created for the fishing club. Areas of drainage were also improved around the site to enhance the circular walk and the sluice cleared of silt and debris to allow proper operation.
